Concrete Consolidation and the Potential for Voids in ICF Walls

Abstract: This report summarizes the findings of a study regarding concrete consolidation and the potential for voids in insulating concrete form (ICF) walls. Eighty-four wall sections were constructed to represent a variety of configurations including clear wall sections, corners, and lintels. Concrete was placed and consolidated using internal vibration, external vibration, and by modifying the concrete flow (slump). Results of the study showed that internal vibration could provide adequately consolidated concrete as long as proper vibrating techniques were maintained. In areas of high rebar congestion, such as lintels and corners, additional care must be used in order to achieve adequate consolidation. These areas are often key structural regions and must have proper consolidation around reinforcement. As an alternative to internal vibration, adequate consolidation also was achieved with a flowable (high slump) concrete. To produce a flowable concrete, it is recommended that a high-range water-reducing admixture or self-consolidating concrete mix design be used in lieu of water addition. This will maintain adequate

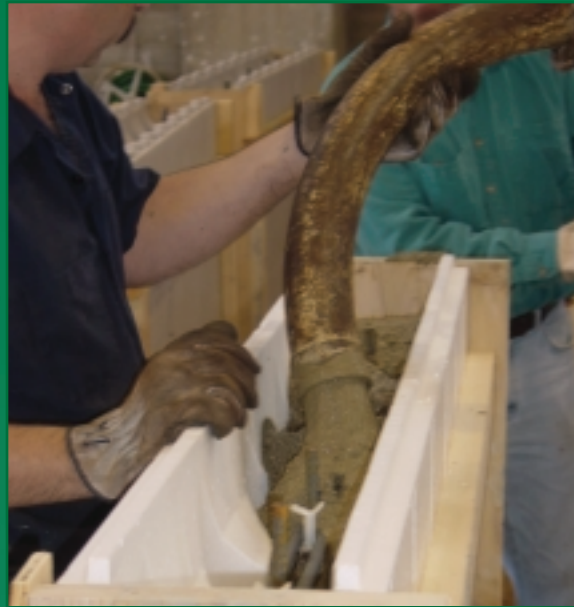
Cover Photo: Pumping concrete into ICF (IMG13417).

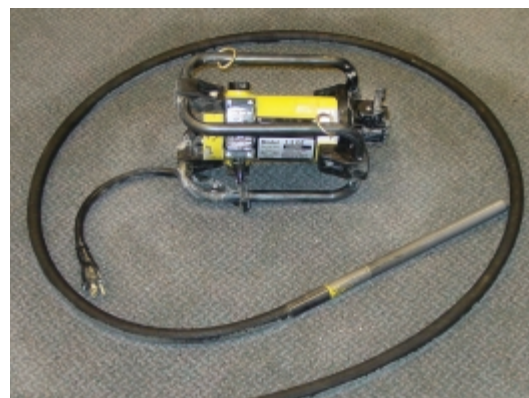
Internal vibration. A 0.9 kW (1.2 HP, 9 amp) concrete “pencil rod” vibrator (Figure 5) with a 20-mm (¾-in.)

Figure 5. Internal concrete vibrator (disassembled). (IMG13338)

diameter head was used to internally vibrate and consolidate the concrete. This particular vibrator, designed for use with ICF walls, operates with amplitude of 0.8 mm (0.03 in.) and a radius of action of 75 mm (3 in.) in typical concrete mixes. A vibrator is the most commonly used tool to consolidate concrete on commercial projects where concrete is cast in reusable formwork.

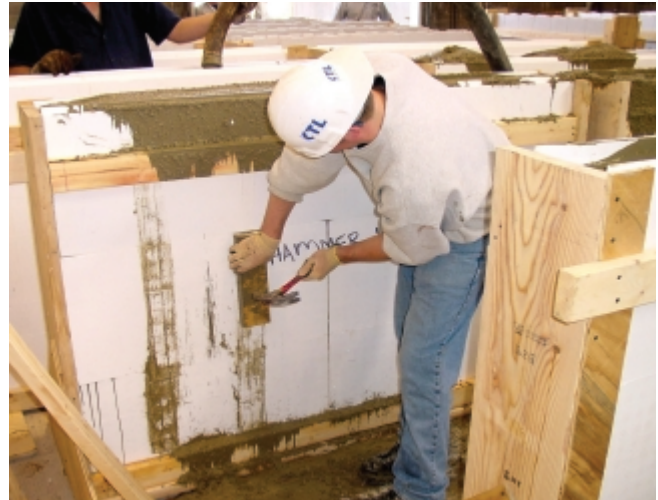
Hammer and wood block. With this consolidation method, a wood block and a standard framing hammer were used for consolidation. The wood block was placed along the plastic ties in the formwork and a standard framing hammer was applied using moderate force to vibrate the formwork. The wood block was moved vertically approximately 150 mm (6 in.) and the process repeated. This consolidation method was tedious and is shown in

Figure 7. Concrete consolidation using a hammer and block of wood. (IMG13339)

Figure 7. Vibration efforts were concentrated on the plastic tie locations of the formwork as not to disrupt the unreinforced polystyrene areas of the formwork, which could lead to potential blowouts. An observant operator could detect changes in sound due to large voids and could concentrate further vibration efforts in this area.

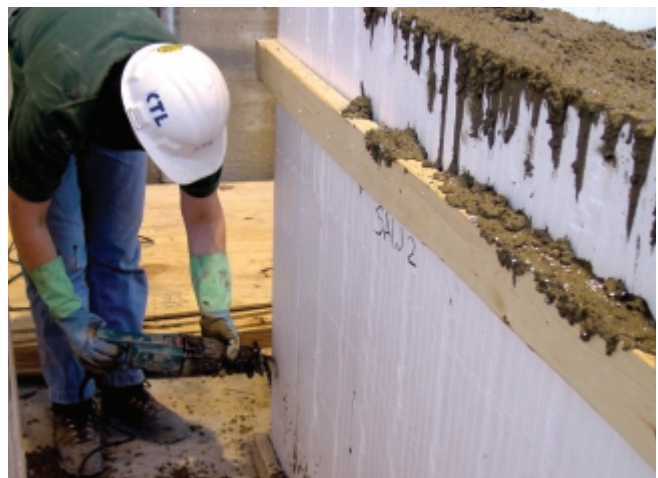
Reciprocating saw. Consolidation of the concrete in ICFs was performed using a reciprocating saw. Efforts were made with both the blade removed and with a bent blade. Consolidation efforts were concentrated in the plastic tie locations to reduce the possibility of blowouts due to forces on the unreinforced polystyrene locations of the formwork. The reciprocating saw was placed at the base of the wall and moved up at a slow rate. The operator was able to watch the concrete level at the top of the form and use changes in sound as an indication of the consolidation efforts. This consolidation method is shown in Figure 8.

Figure 8. Concrete consolidation using a reciprocating saw with a bent blade. (IMG13340)

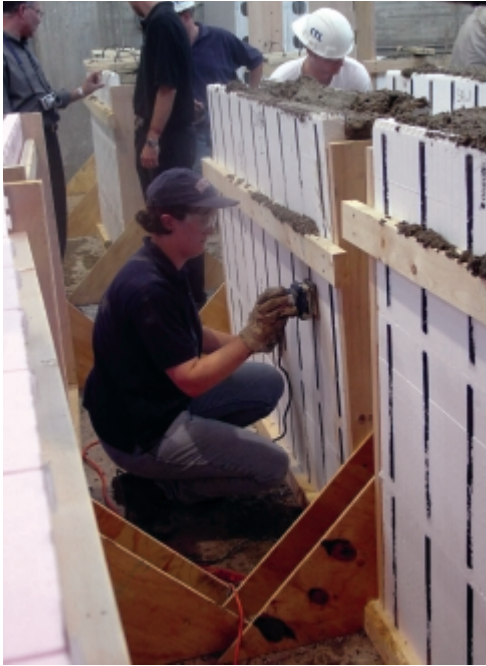
To more effectively transmit shock waves sufficient to consolidate the concrete, it was found that considerable force had to be applied perpendicular to the ICF surface. An observant operator could detect changes in sound as an indication of the quality of concrete consolidation. This consolidation method is shown in Figure 9.

Figure 9. Concrete consolidation using an orbital sander. (IMG13341)

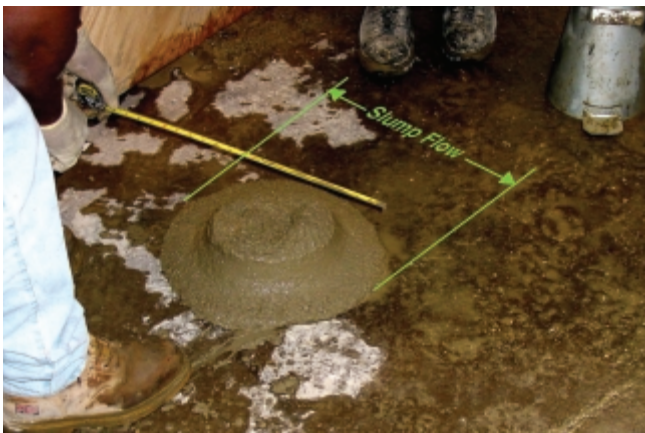
Since SCC mixes are so fluid, a standard slump test is not an accurate indication of the concrete's properties. To measure the flow of a SCC mix, a standard slump cone is filled and removed similarly to that of a standard slump test. However, the diameter of the concrete pile is measured instead of the height drop (Figure 10). The measurement of the concrete diameter is referred to as the slump flow. The SCC mix used in this project started with a 560-mm (22-in.) slump flow and stiffened to a 410-mm (16-in.) slump flow over time.

Figure 10. Measurement of slump flow for the SCC. (IMG13342)

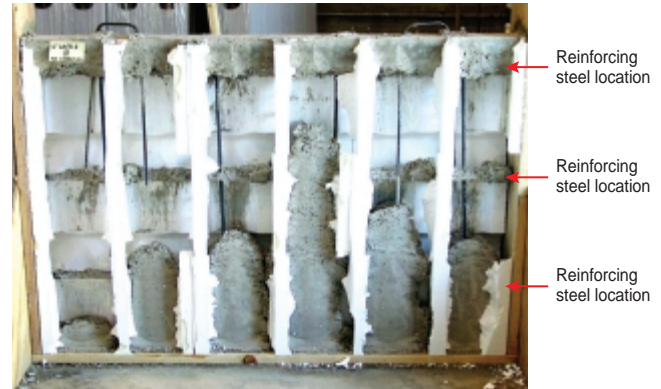
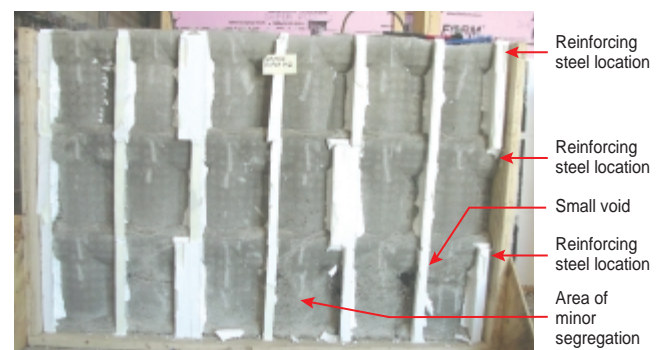
When mechanical vibration was not utilized, the most reliable way to minimize voids was to use a flowable concrete. This is illustrated in Figures 12 through 15. No discernible difference was found between the different types of ICFs.

Figure 12. Waffle-grid ICF with low slump concrete and no mechanical vibration. (IMG13344)

Figure 13. Flat-panel ICF with medium-low slump concrete and no mechanical vibration. (IMG13345)

Figure 14. Waffle-grid ICF with medium-high slump concrete and no mechanical vibration. (IMG13346)

Figure 15. Waffle-grid ICF with high slump concrete and no mechanical vibration. (IMG13347)

With the standard concrete mix (low and medium-low slump concrete), and no mechanical vibration, there was often extensive voiding. Voids typically were noted in areas of steel congestion, particularly below the lap regions of horizontal reinforcement.

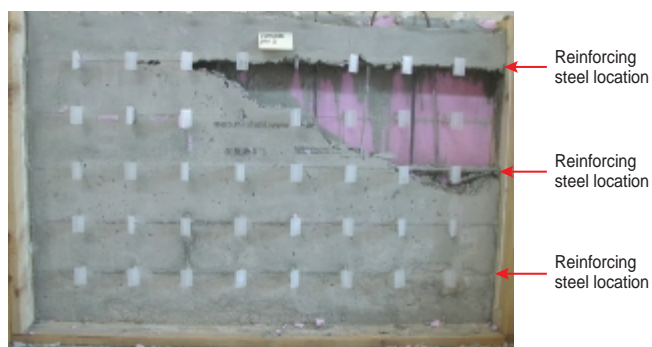
For the low slump concrete, external mechanical vibration of the formwork did not significantly decrease voiding. For the medium-low slump concrete, external vibration marginally reduced voiding; however, significant voids were noted in many wall sections. Of these methods, the hammer and wood block method was the most effective but also the most tedious. It is likely its effectiveness would be decreased on larger placements.

Internal vibration was more effective than external vibration, but still left larger voids with a low slump concrete. For medium-low slump concrete, internal vibration significantly reduced the size and quantity of the voids. Figures 16 through 19 show the results of the various vibration methods for wall sections with medium-low slump concrete. Note that it is likely that if the internal vibration was done in exact accordance with manufacturer instructions (see the description of the actual vibration practice), voids would have been minimized or eliminated.

Figure 16. Flat-panel ICF with medium-low slump concrete vibrated with a hammer and wood block. (IMG13348)

Figure 17. Flat-panel ICF with medium-low slump concrete vibrated with a reciprocating saw. (IMG13349)

Figure 18. Flat-panel ICF with medium-low slump concrete vibrated with an orbital sander. (IMG13350)

Figure 19. Flat-panel ICF with medium-low slump concrete vibrated with an internal vibrator. (IMG13351)

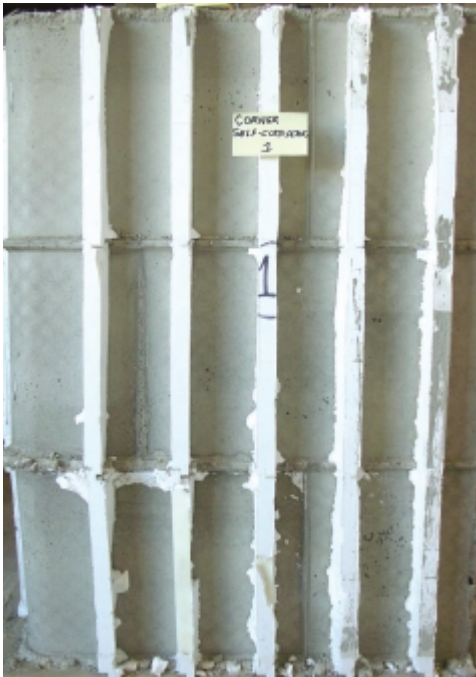
Although the use of internal vibration reduced the amount of voiding, a high slump concrete provided adequate consolidation in the corners (Figure 21) when placed as recommended by ICF manufacturers.

Figure 21. Flat-panel ICF corner configuration with high slump concrete. (IMG13353)

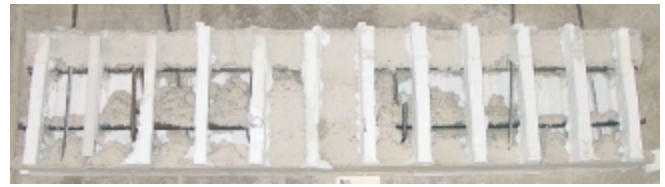
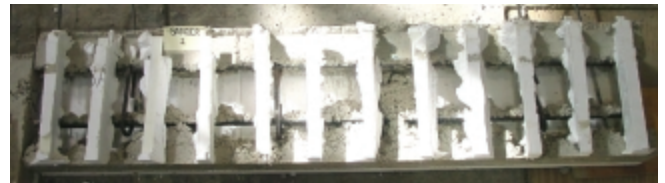
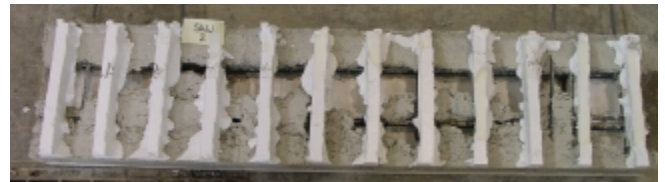
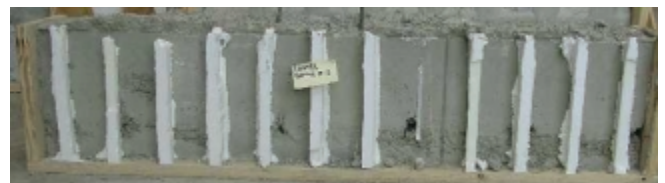
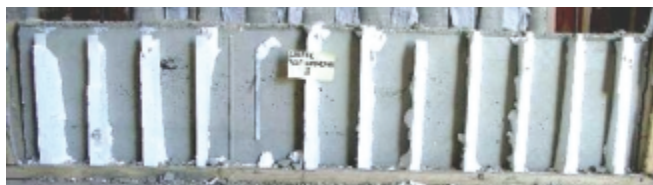
Due to the high rebar congestion in the lintels, voiding was problematic, especially with the lower slump concretes. As illustrated in Figures 22 through 28, internal vibration and/or flowable (medium-high and high slump) concrete mixes are recommended to ensure minimal voids in this sensitive area. Utilizing both internal vibration and flowable concrete would be ideal.

Figure 22. Flat-panel ICF lintel with low slump concrete and no mechanical vibration. (IMG13354)

Figure 23. Flat-panel ICF lintel with low slump concrete vibrated with an orbital sander. (IMG13355)

Figure 24. Flat-panel ICF lintel with low slump concrete vibrated with a hammer and block. (IMG13369)

Figure 25. Flat-panel ICF lintel with low slump concrete vibrated with a reciprocating saw. (IMG13371)

Figure 27. Flat-panel ICF lintel with medium-high slump concrete (no mechanical vibration). (IMG13375)

Figure 28. Flat-panel ICF lintel with high slump concrete (no mechanical vibration). (IMG13377)

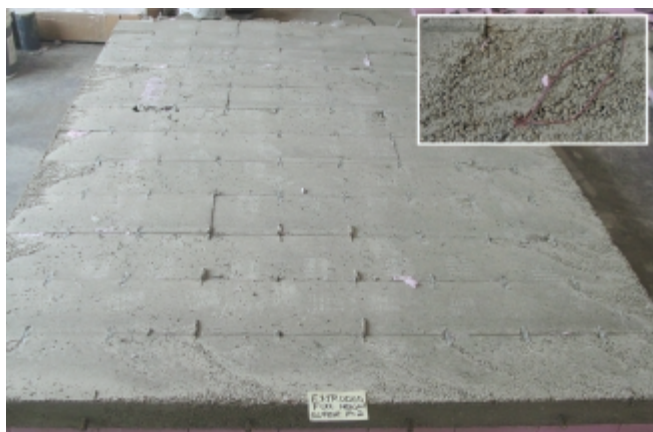
Concrete lifts typically are limited to 1200 mm (4 ft) by code and based on ICF manufacturer guidelines. In the full height (2400 mm [8 ft]) wall sections, segregation was noted near the sides and bottom for the medium-low and medium-high slump concrete (Figure 29). Segregation was significantly reduced in the walls with SCC (Figure 30).

Figure 29. Full height flat-panel ICF with medium-high slump concrete (no mechanical vibration). Note the closeup view of an area with segregation. (IMG13379, IMG13624 [insert])

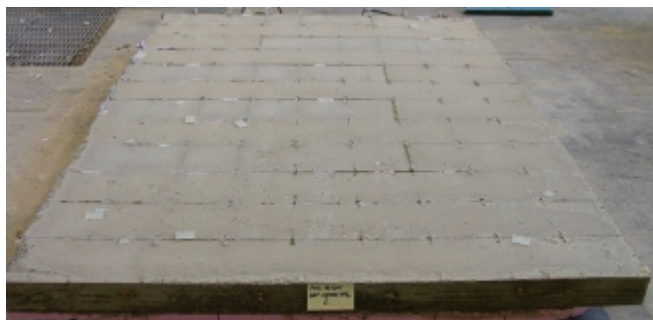
Figure 30. Full height flat-panel ICF with high slump concrete (no mechanical vibration). (IMG13382)
